SITE SURVEY REPORT

Emergency Shower Inspection

Prepared for	Dearne Water Services Ltd
Date	28 Sep 2026
Site	Westmoor Water Treatment Works, Barnsley
Prepared by	F. Okafor

Station ID and location	ES-03, combined safety shower and eyewash, outside the sodium hypochlorite dosing room
Hazards and risk assessment reference	Splash from sodium hypochlorite and sodium hydroxide during delivery and dosing. COSHH assessment COSHH-WM-05.
Manufacturer checking procedure and revision	Maker's weekly activation and inspection sheet, rev 2
Approved checking schedule and responsible person	Weekly activation, site schedule PPM-WM-ES, responsible person F. Okafor

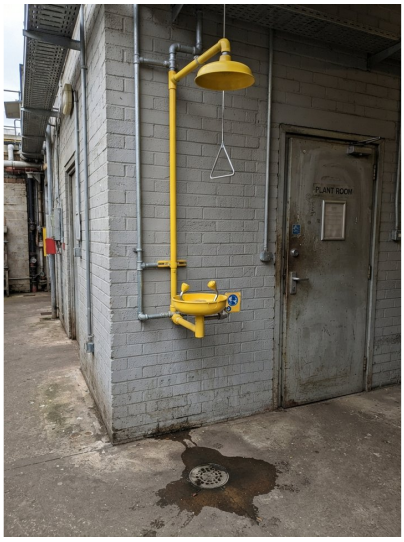
Access route and operating space clear	Acceptable
Station markings and operating instructions visible	Acceptable
Actuator and shower head visibly intact	Acceptable
Supply and drainage visibly checked within scope	Action needed
Action, limitation or reason not applicable	Floor drain under the shower slow to clear. Water pooled for about two minutes after the test.
Privacy and cold-weather arrangements checked where required	Acceptable

Further action 1: Clear the floor drain under ES-03 and test the flow.

Action and evidence reference	Clear the floor drain under ES-03 and test the flow.
Person responsible	Site maintenance team, WO-WM-7714
Target date	2 Oct 2026
Action status	Open
Outstanding limitations and information to pass on	Drain slow to clear. Shower and eyewash fully working.
Record status	Ready for review
Reviewed by	B. Shaw, site manager
Review date	29 Sep 2026
Author signature
