Gutter Clearance Report

Prepared for	M. Foster
Date	12 Oct 2026
Site	9 Willow Way
Prepared by	K. Lane

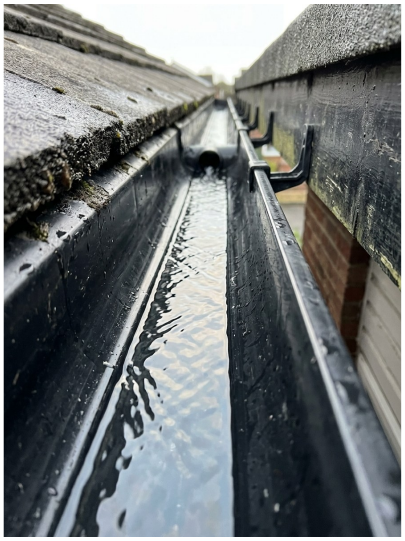
Height to the gutter (m): measuring photo

Elevation or run (for example front, rear, garage)	Front elevation
Length (m)	9.5
Height to the gutter (m)	5.90
