SITE SURVEY REPORT

LOLER Thorough Examination Record

Prepared for	Midlands Fabrication Ltd
Date	6 Oct 2026
Site	Midlands Fabrication
Prepared by	H. Briggs

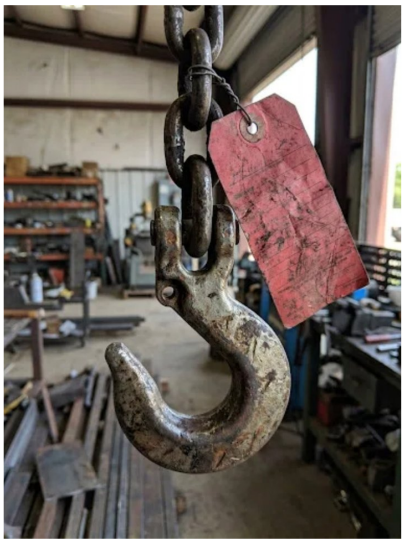
Equipment examined here 2: CH-14

Identification or asset number	CH-14
Type	Lifting accessory (sling, shackle, eyebolt)
Position in this area	Rack
Safe working load	2 t
Date of manufacture (if known)	Not known
Date of the last thorough examination	8 Apr 2026
Days since the last thorough examination	181
Used to lift people?	No
Examination	Every 6 months
Result	Dangerous defect: do not use

Defects found and repairs needed	Hook safety catch missing and throat opened beyond the manufacturer's limit. Quarantined and tagged. Employer told at 09:40 on the day.

> Dangerous defect. The examiner must tell the employer straight away, and where there is an existing or imminent risk of serious personal injury, send a copy of the report to the enforcing authority as soon as practicable. The employer must make sure the equipment is not used until the defect is put right.

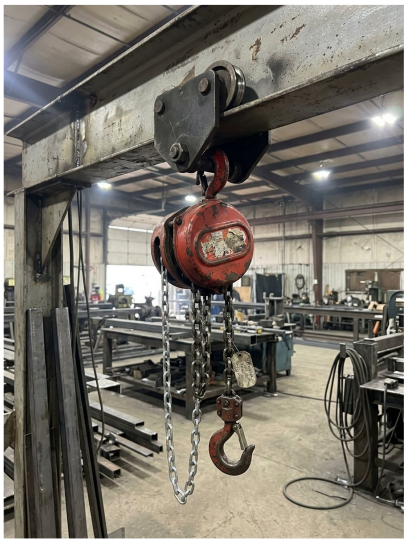
Equipment examined here 1: CB-03

Identification or asset number	CB-03
Type	Hoist
Position in this area	Gantry
Safe working load	1 t
Date of manufacture (if known)	2016
Date of the last thorough examination	2 Sep 2025
Days since the last thorough examination	399
Used to lift people?	No
Examination	Every 12 months

> The last thorough examination was more than 12 months before this one. On a 12-month basis (LOLER regulation 9(3)(a)(ii)) the equipment was overdue: record why, and whether it was used while overdue.

Result	Safe to use
Latest date for the next thorough examination	6 Oct 2027
Days from this examination to the next	365
